## **Eurostar Independent Review**

**February 12, 2010**

# **EUROSTAR INDEPENDENT REVIEW**

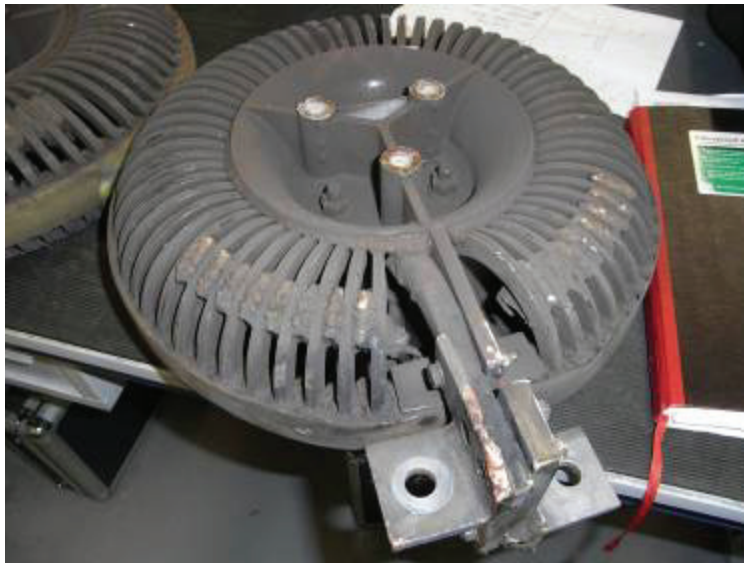
Fig 1 below shows the damage caused to the inductor as a result of its proximity to the pan well roof:

d) Train 9055 initially lost one motor bloc due to arcing from an inductor. Three more then failed due to a series of similar incidents and arcing in the power factor corrector circuits.

The snow also accumulated in the pantograph well, resulting in a very cold surface above the motor blocs. This resulted in condensation falling on the inductors which caused arcing to the surrounding metal, particularly that of the roof and the reinforcing struts, which are very close to these components (see recommendation 4).
