## **Eurostar Independent Review**

**February 12, 2010**

# **EUROSTAR INDEPENDENT REVIEW**

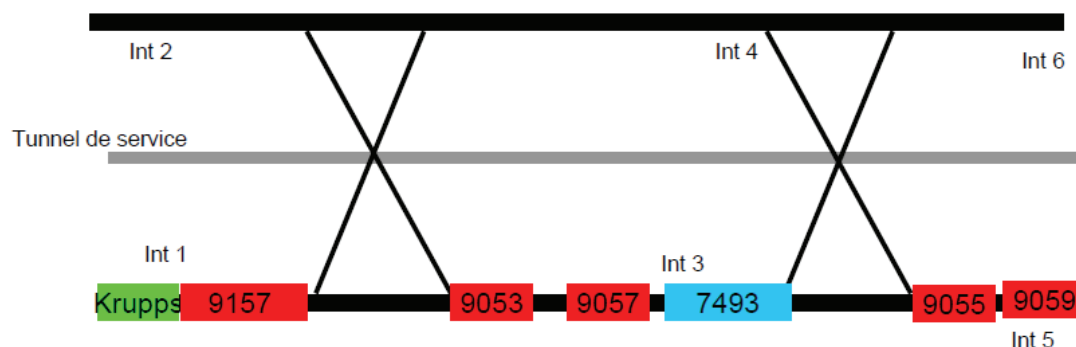
During transit of this group, train 9053 failed in tunnel Interval 3, just before the UK-end crossover, at approximately 22.40hrs. As a result, the other three Eurostar trains in this group were stopped behind the 9053.

Train 9057, which was travelling from Disneyland Paris, was held in Interval 3 in the mid-point of the Tunnel, together with an HGV shuttle (7943). The 9055 and 9059 services, which were travelling behind the Disney train, were stopped in interval 5 (see diagram below).

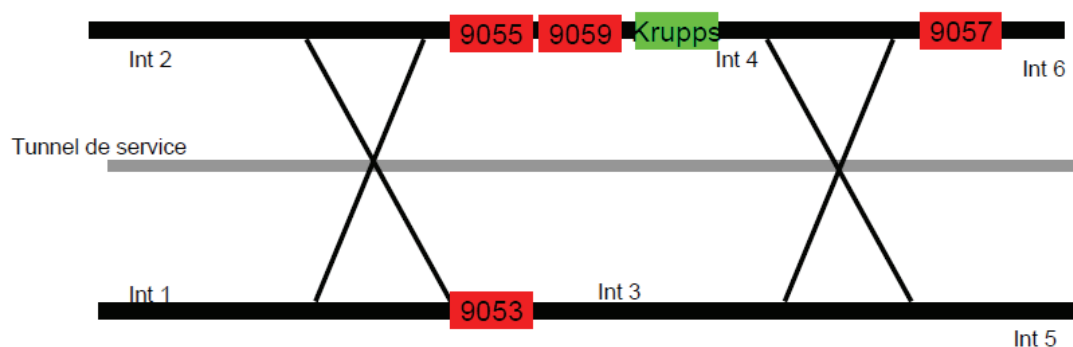
Finally, at 01.00hrs, train 9057 failed and its pantograph dropped while travelling through tunnel Interval 6 on its return journey to Calais. The diagram below shows trains in their final positions when four had failed within the Tunnel:

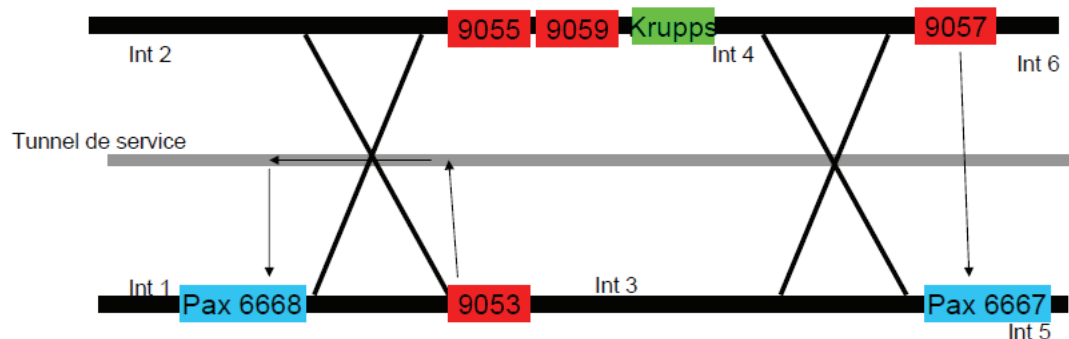
With one train having been towed from the Tunnel towards Folkestone, four trains now needed to be recovered. The evacuation plan was as follows:

- 1) The Krupps Rescue Locomotive from Calais would 'push' the 9055 and 9059 through the north tunnel to the UK emergency sidings
- 2) Passengers from train 9053 would be evacuated onto Eurotunnel vehicle shuttle 6668 and proceed to the UK through the south tunnel
- 3) Passengers from train 9057 would be evacuated onto Eurotunnel vehicle shuttle 6667 and return to Coquelles (back through the south tunnel)
